OFFICE OF THE PROJECT MANAGER CHEM DEMILITARIZATION I--ETC F/G 15/2  
DEMILITARIZATION PLAN OPERATION OF THE CHEMICAL AGENT MUNITIONS--ETC(U)  
MAR 77 A A 05600D

DRCPM-DRD-SP-77013

②  
DEMILITARIZATION PLAN  
OPERATION  
OF THE  
CHEMICAL AGENT MUNITIONS DISPOSAL SYSTEM  
(CAMES)  
AT  
TOOELE ARMY DEPOT,

Final Report for Bench Scale Corrosion Study

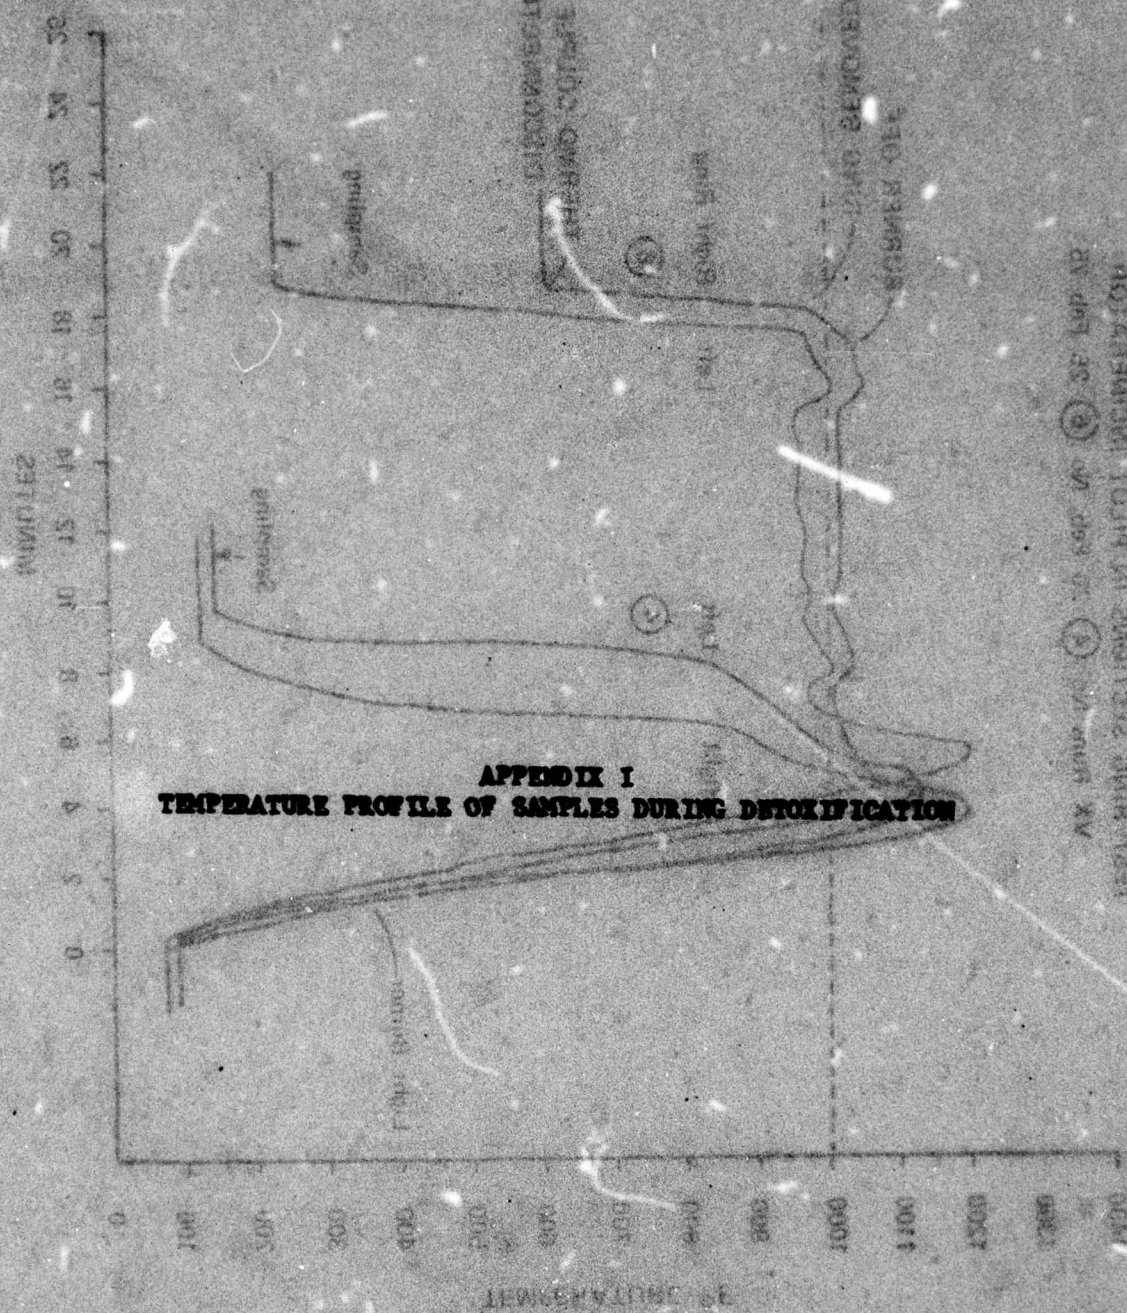
TEST RING SECTIONS IN PILOT INCINERATOR  
 VX Runs No ④ 20 Feb, No ⑥ 25 Feb 75

Conditions of this run parallel those of GB Run #5, all the binder was burned off the FRP tube. The VX level of both rings and of the control pail were  $<0.125 \times 10^{-4}$ , below the detectable VX level for this test, and 2.5 times lower than the VX stack standard. VX was detected in the capsule atmosphere, indicating that the test could detect VX.

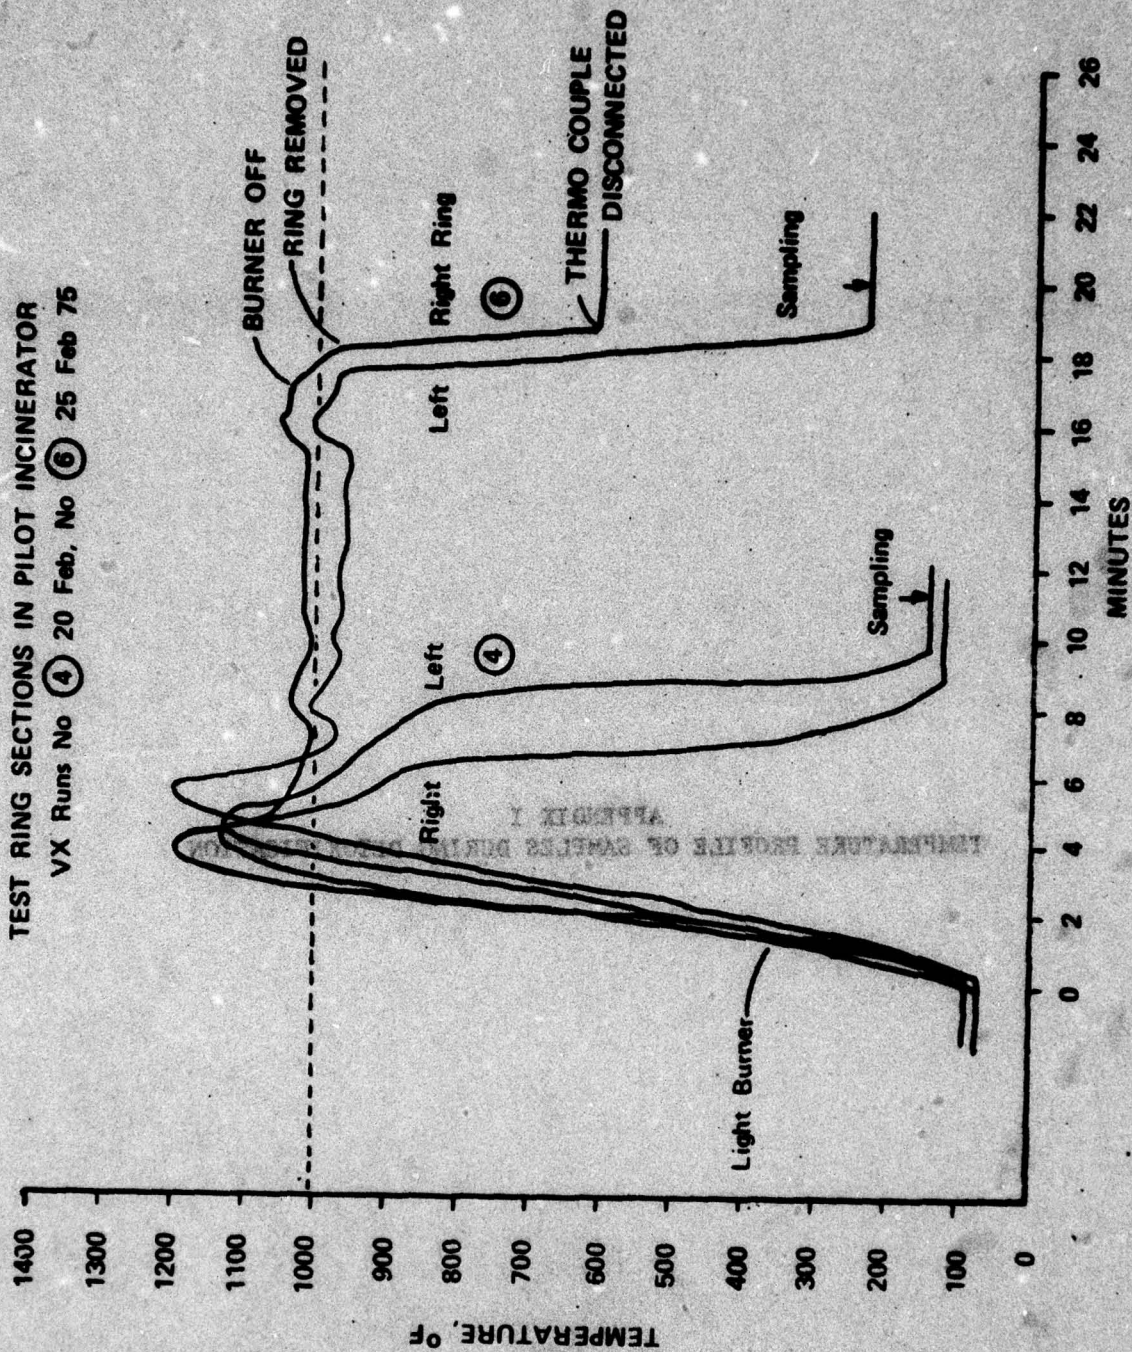
FIGURE 1 THERMAL DETOXIFICATION OF M55 ROCKETS

The average GB background level in the clean capsule is  $3.9 \times 10^{-4}$  mg/m<sup>3</sup> or almost four times the minimum detectable level. This is an appreciably larger discrepancy than found in later tests, for example run #5, where three samples had less GB than the minimum detectable but the fourth one had 20% GB over the minimum detectable.

The only procedural changes between this and previous runs was that the pail lids were crimped on rather than taped and that pails and bubblers were located outside of the capsule in the normal pilot plant atmosphere. All the organics were burned off the fiberglass and the aluminum rings were 70-90% coated with carbon black. Both bubblers of the left ring and one of the right ring were below the detectable limit of the test,  $<0.625 \times 10^{-4}$  mg/m<sup>3</sup>. The second right ring bubbler had a GB level barely above the detectable,  $0.75 \times 10^{-4}$  mg/m<sup>3</sup>. It is believed that this slight deviation reflects more on the accuracy of this test at the threshold limit of its sensitivity rather than indicates the presence of GB in the bubbler. This bubbler was only 20% above the lowest detectable level which is very little, compared to the background GB levels found during the dry run (run #1) before agents were introduced in this test series. At this time the average GB background level was four times the minimum detectable. The 20% discrepancies of this test is also much lower than

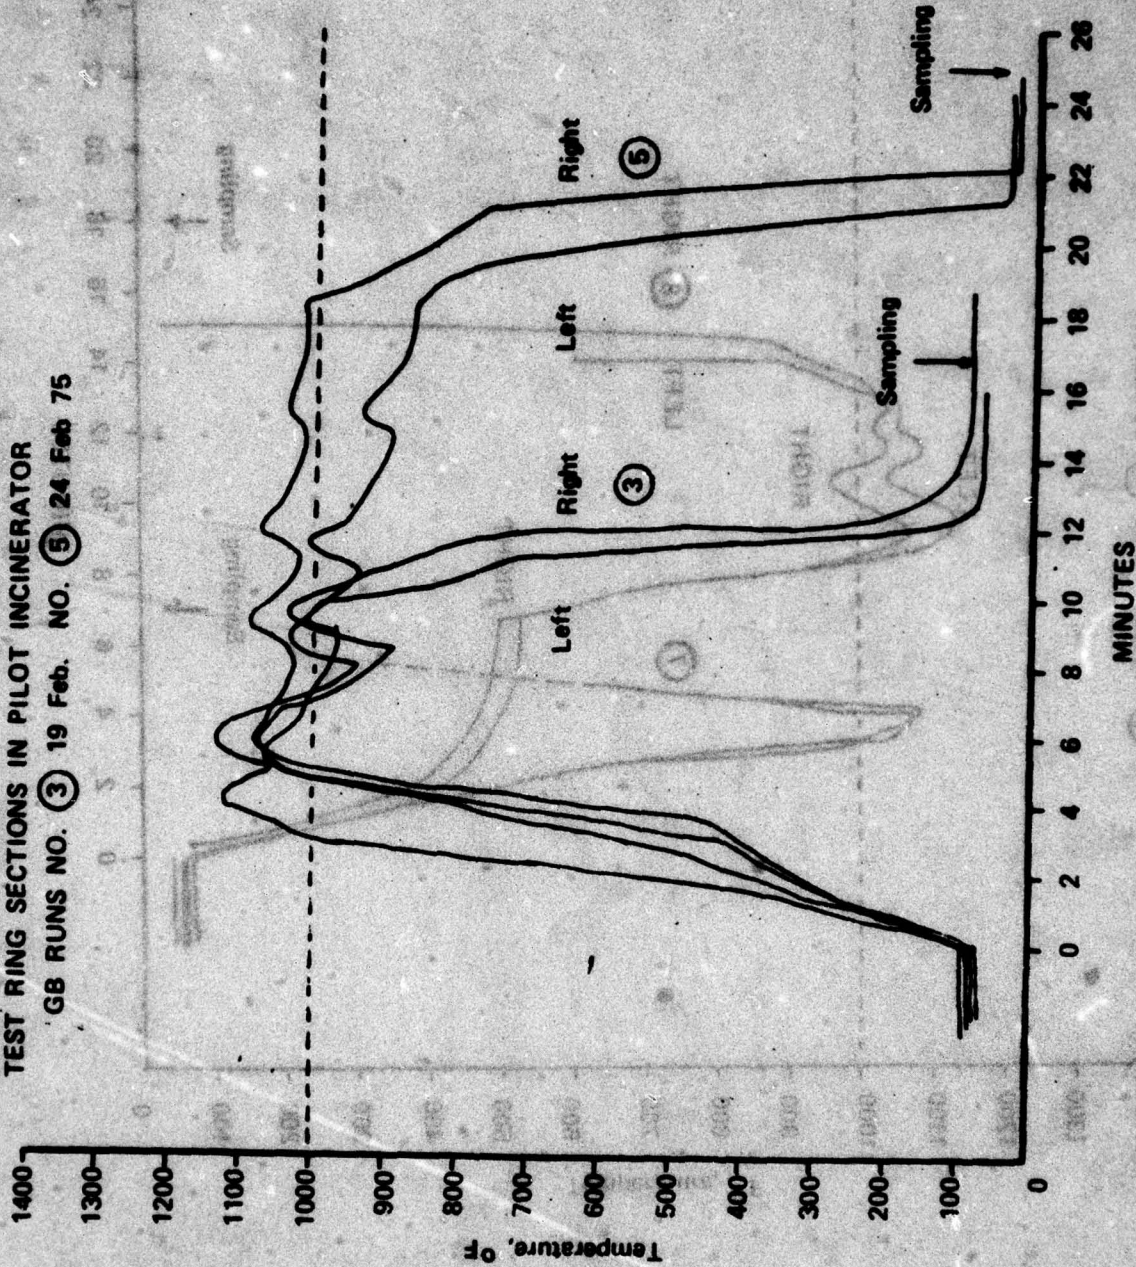
FIGURE 2 THERMAL DETOXIFICATION OF M55 ROCKETS

The one minute residence time was much too short to burn off the polyester binder of the rocket tube, on removal from the oven they continued to burn actively for about 1/2 min. After the burning stopped the rings were put in their respective pails. The right pail and the blank control pail were below the detectable level for GB,  $<0.67 \times 10^{-4}$  mg GB/m<sup>3</sup> while the left pail had 2.5 and  $2.83 \times 10^{-4}$  mg GB/m<sup>3</sup> air. The one minute residence time is clearly insufficient to incinerate the binder of the rocket tubes. If any agent had penetrated within the fiberglass matrix there is no assurance that it would have been exposed to sufficient temperature to be detoxified.

At the start of this run the furnace flamed out, this resulted in a four minute delay during a preprogrammed purge cycle during which the temperature leveled off at 500°F for about 3 minutes before resuming its ascent to 1000°F. Both bubblers of the left pail were below the detectable level for this test  $<1.24 \times 10^{-4}$  mg/m<sup>3</sup>. While the right bubblers averaged  $5.17 \times 10^{-4}$  mg/m<sup>3</sup>. This represents a four fold average difference which is probably real. The discrepancy between the two bubblers of the blank pail is more questionable. While one was  $<1.24 \times 10^{-4}$  the other one was  $2.06 \times 10^{-4}$  mg/m<sup>3</sup>. This 70% increase over the minimum detectable level seriously challenges the reliability of the test since there should be no agent in the air sample of this blank pail, unless there was an unreported agent leak in the pilot plant ambient atmosphere. With these types and levels of discrepancies, the slight anomaly of run 5 becomes increasingly acceptable.
